Version 1.1
Supplemental Remedial Investigation Report
February 2008

Supplemental Remedial Investigation
Tulsa Fuel and Manufacturing Superfund Site
Collinsville, Oklahoma

Tulsa Fuel and Manufacturing Superfund Site
Collinsville, Tulsa County, Oklahoma

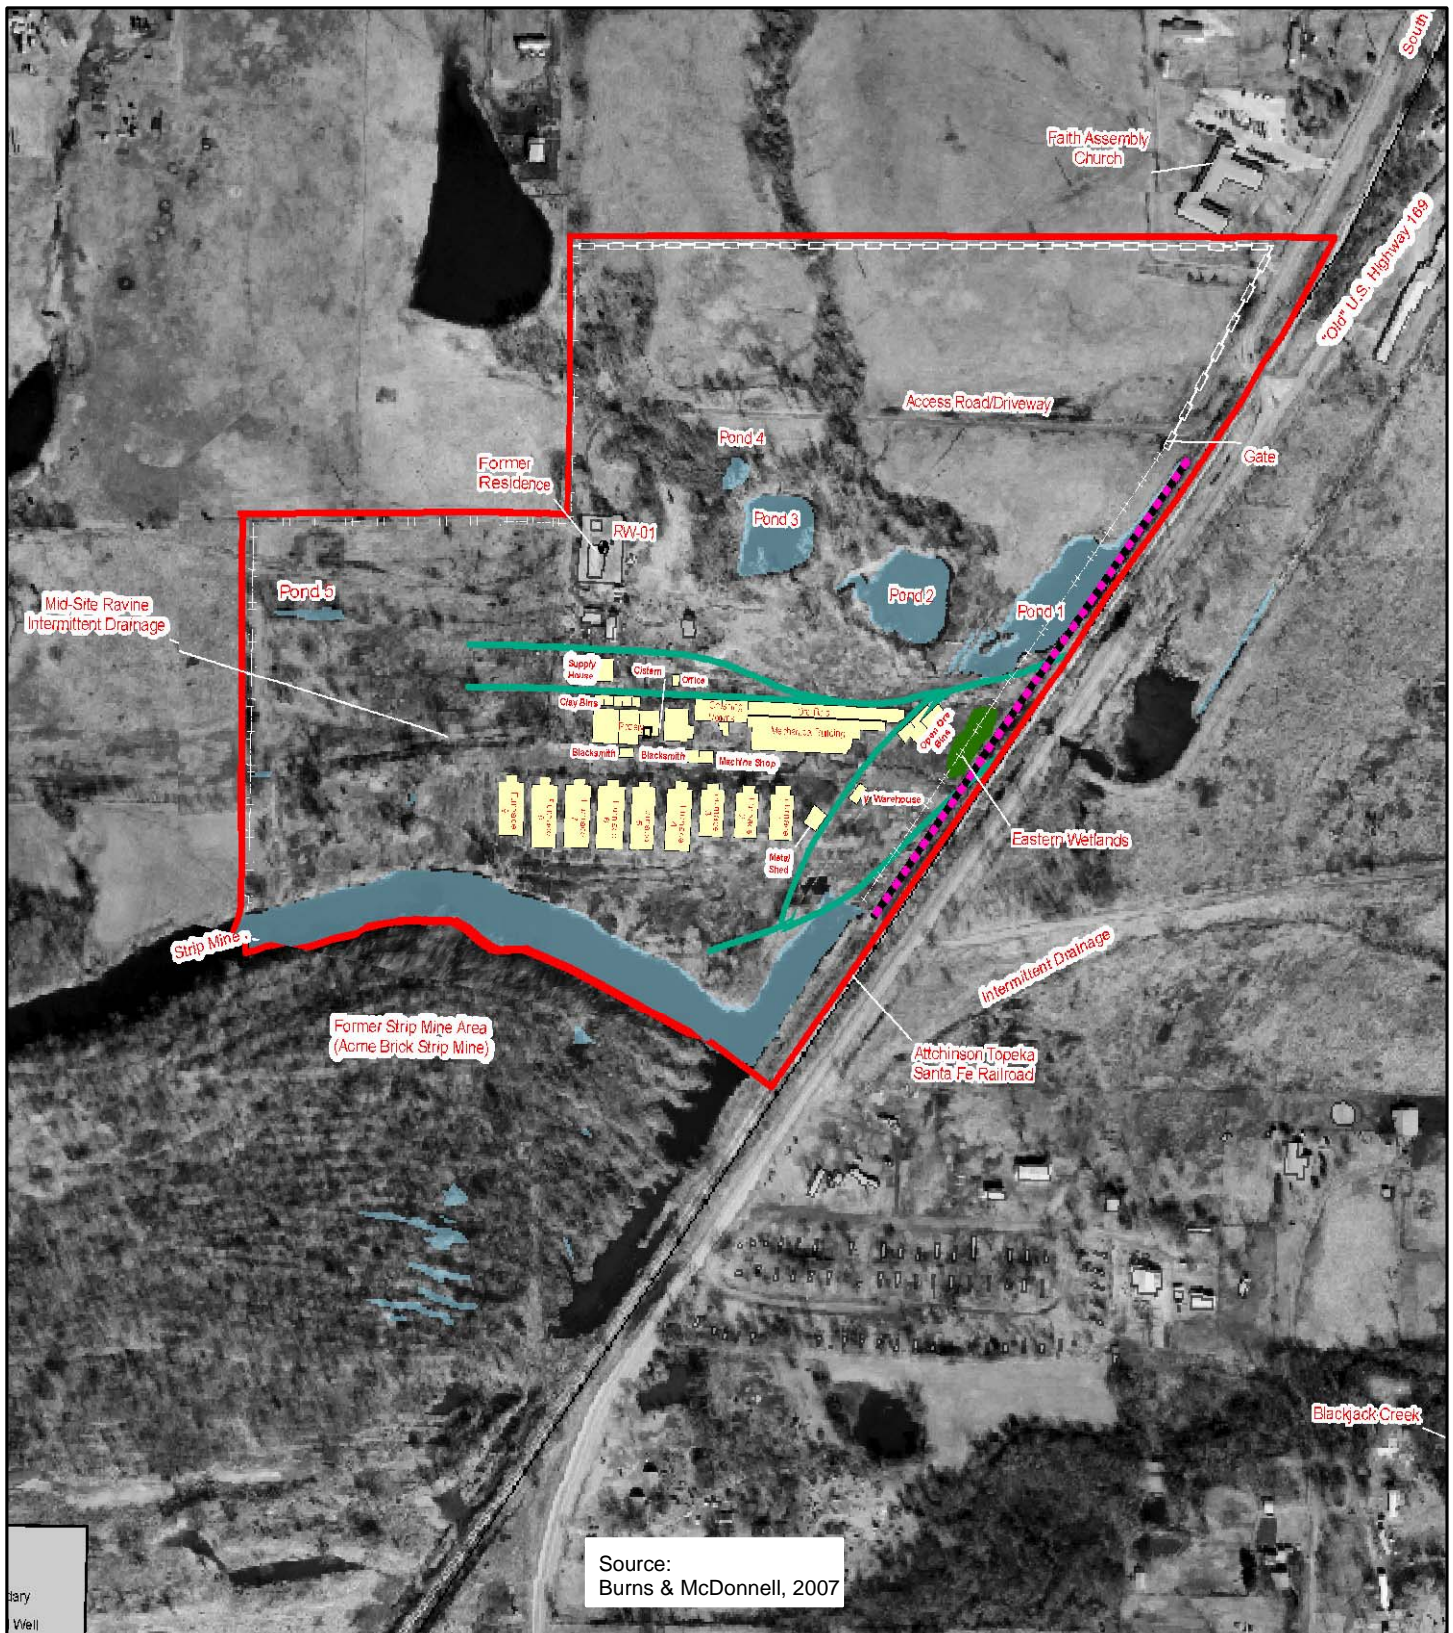
Figure 3-1
SITE TOPOGRAPHY AND
AERIAL PHOTOGRAPH
 SUPPLEMENTAL REMEDIAL
 INVESTIGATION
 TULSA FUEL AND MANUFACTURING
 Collinsville, OK

The OSDH 1992 PA report indicates that the site consists of about 50 acres; however, the ODEQ 2007 RI report indicates that the site actually consists of approximately 60.7 acres ([Figure 3-1](#)). Of the 60.7 acres, ODEQ 2007 RI report estimates that about 25 acres of surface is covered, to varying degrees, with smelter waste material such as broken retorts, slag, building debris, ash, and brick (ODEQ, 2007).
